TRANZBAND MAINTENANCE & REPAIRS GUIDE

This guide is designed to help decrease the maintenance needs of your Lineshaft/Tranzband conveyor, and where maintenance is required, make it simple.

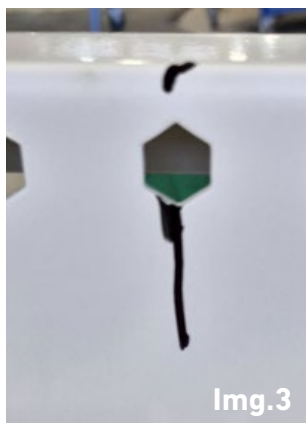
To begin repairs, mark the inside of the frame holes that have/had rollers located in them (Img.3 below).

Once marked, remove rollers from the section to be repaired.

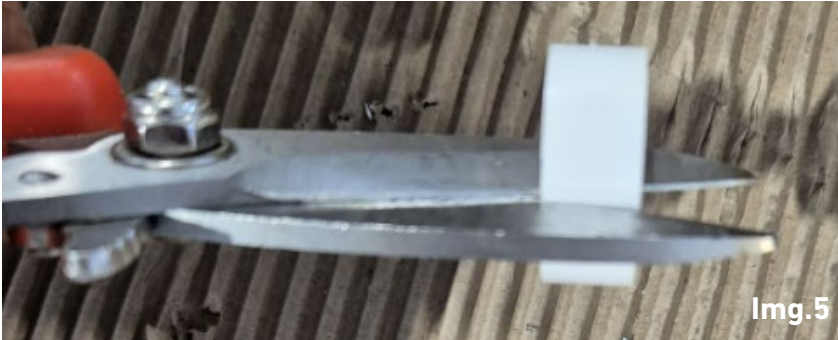
Img.5

Spacers up to 20mm wide can be cut and clipped onto shaft (Img.5 & Img.6 below).

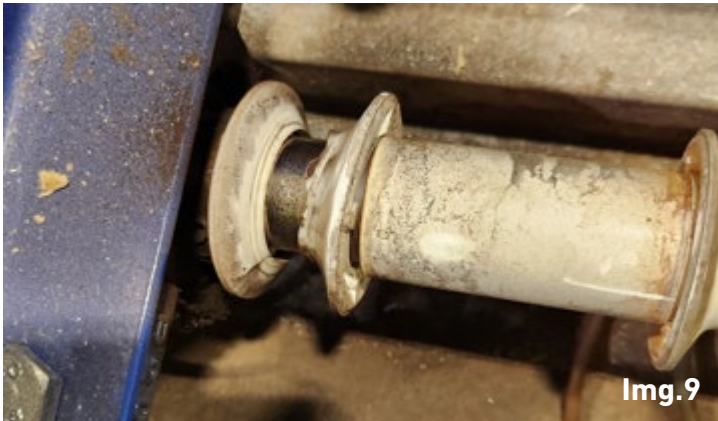
If the spool is damaged or split, this must be replaced immediately (Img.9 below). Remove the shaft and replace.

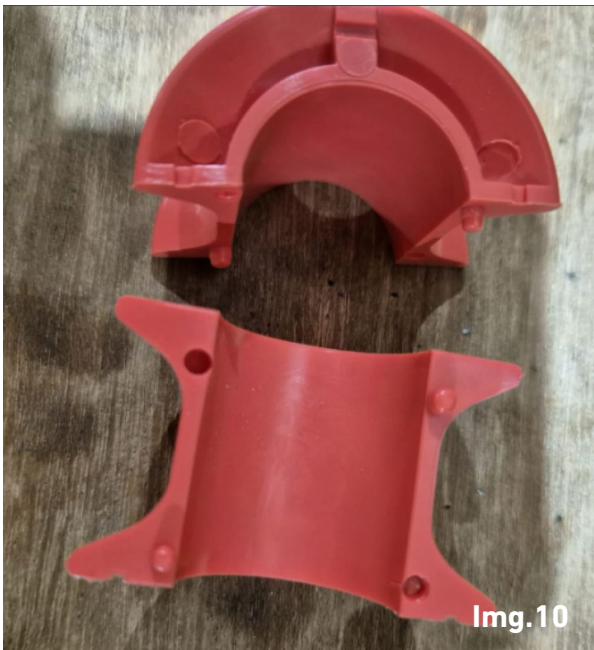
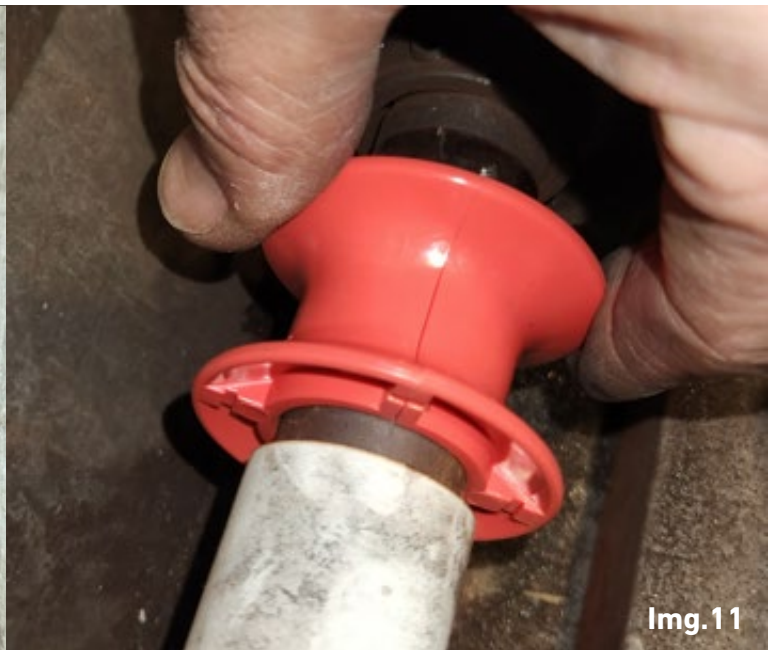
If it is not possible to remove the shaft, cut the spool with a chisel and hammer to remove. Then the spool can be replaced by using a red split spool (Img.10 & Img.11 below).
